LABORATORY EVALUATION OF AN IN-SITU COATING PROCESS FOR MITIGATION OF LEAD AND COPPER IN DRINKING WATER

Vincent F. Hock, Erik Kirstein, Kent W. Smothers, Jeremy L. Overmann
U.S. Army Corps of Engineers
Champaign, IL 61826, USA
217-373-6753

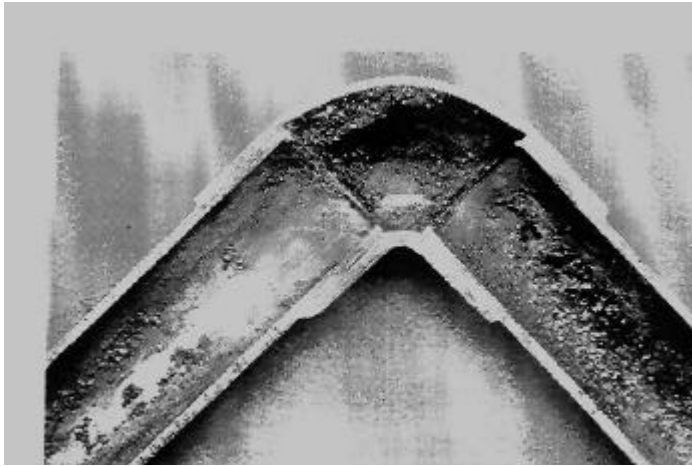
Figure 1. Copper tube showing workmanship defect, i.e., unreamed tube ends, solder globs, and excess solder flux.

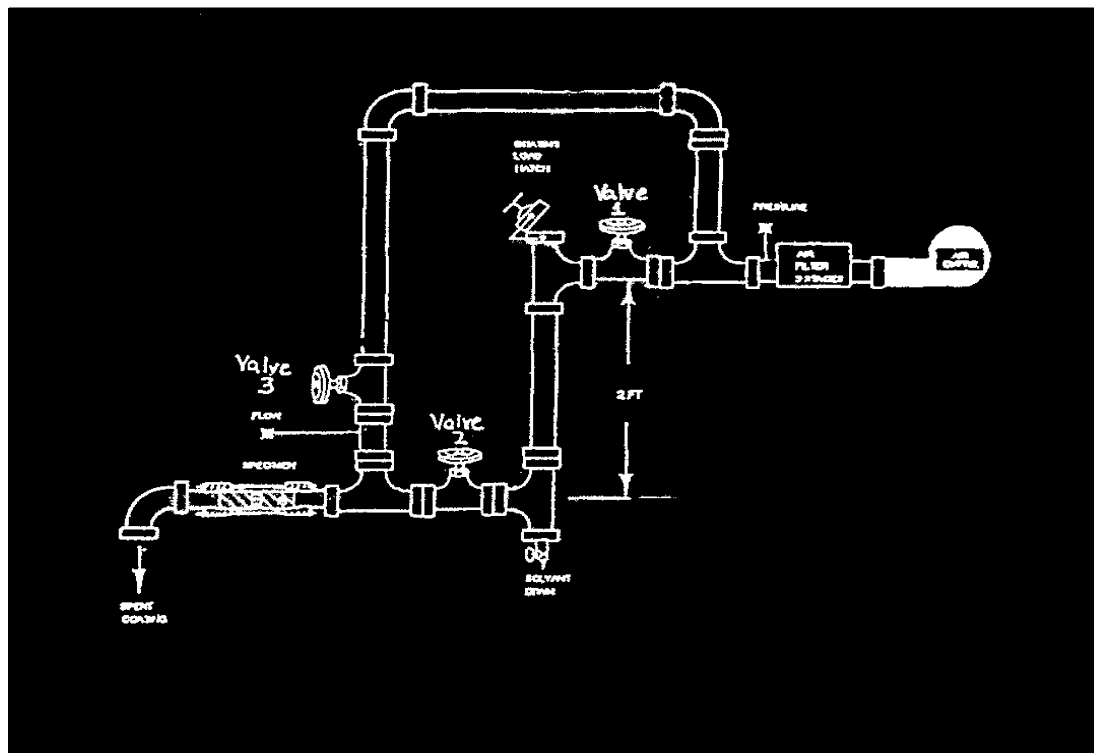
Figure 2. In-situ coating application loop.

The initial phase of the laboratory investigation was to determine whether a coating or lining could be applied in-situ to existing small diameter (1"-2") pipes or tubes. The experimental procedures consisted of fabricating copper pipe specimens, abrasively cleaning the interior surface followed by either blowing through or depositing the 100% solids epoxy coating. The coating application loop is represented in Figure 2. The epoxy coating was then air cured. The evaluation consisted of sectioning the specimens and measuring the coating thickness to determine uniformity of each application technique, in addition to taking weekly water analysis samples to determine lead ion contents.
